# **GREEN SHEET**

### **Informational Summary Report of Serious CDF Injuries, Illnesses, Accidents and Near-Miss Incidents**

#### **Water Tender Rollover with Minor Firefighter Injuries**

**Water Tender 2741**

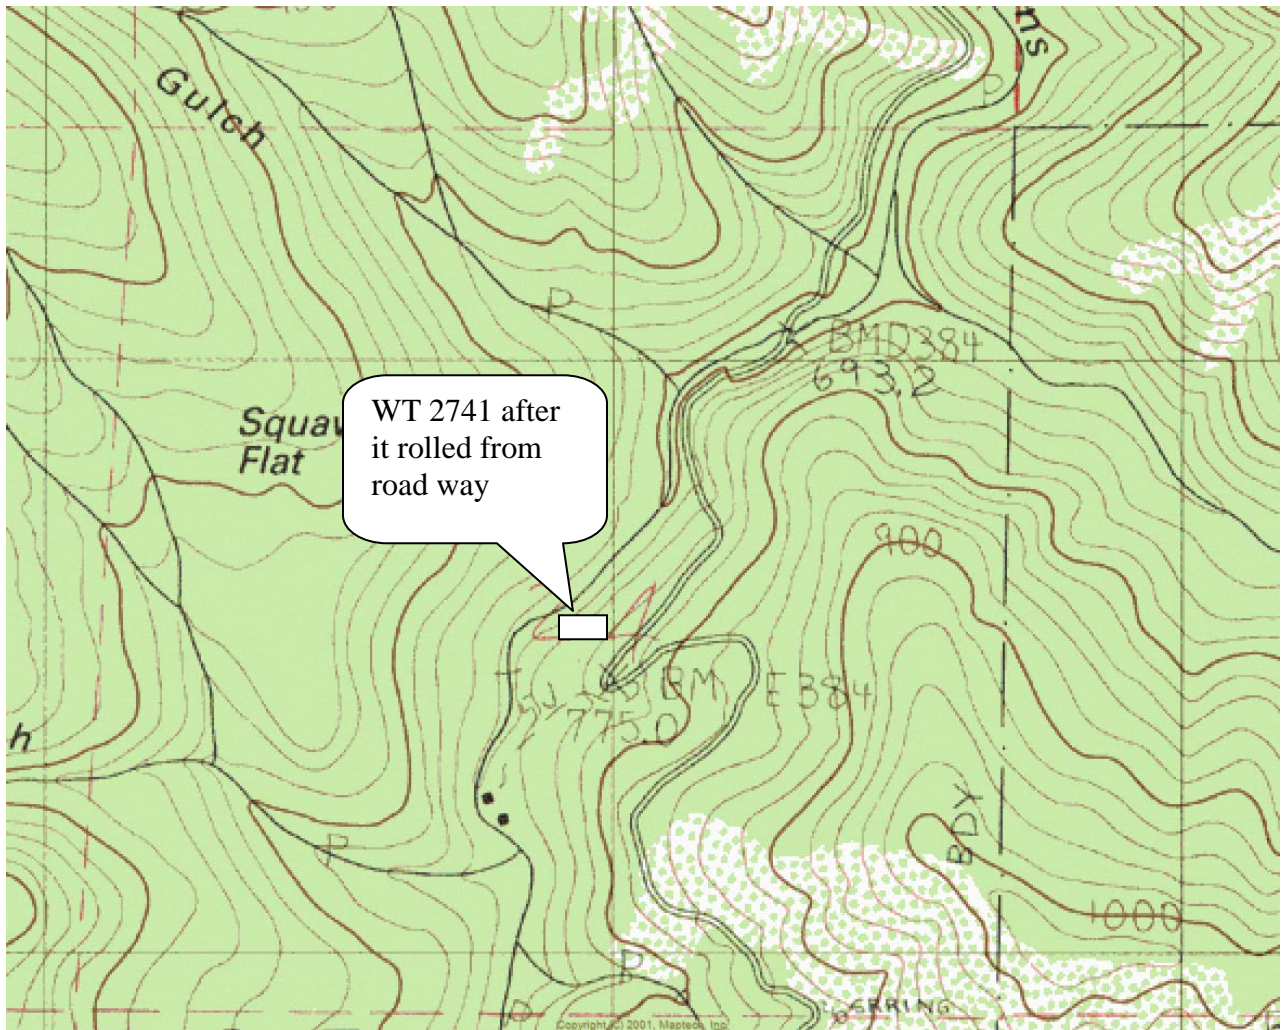
At the eight mile marker, on a grade of approximately 20 percent, the water tender was traveling on a road surface that varied from 9 feet to 9 feet 8 inches in width. The operator encountered an erosion slide caused by winter runoff that reduced the road width from 9 feet to an average of 7 feet 5 inches for approximately 38 feet. The slide measured approximately 2 feet 5 inches in height and had been slightly compacted by vehicles traveling over the top of the slide in advance of the water tender.

**Topography view of accident site. Road surface called Deer Lick Knob at scene. Slide occurred between switchback and accident site, reducing the width of the road surface.**
